## A CASE STUDY: RUPTURE OF THE FLEXOR POLLICIS LONGUS TENDON FOLLOWING DISTAL RADIUS FRACTURE TREATMENT WITH PLATING

Damage to the flexor pollicis longus (FPL) tendon is an uncommon but serious complication after plating for distal radius fractures. This report presents a clinical case of FPL tendon rupture following distal radius fracture fixation, highlighting the potential risk factors for this complication, methods to minimize its occurrence, and the appropriate treatment strategies when it arises.

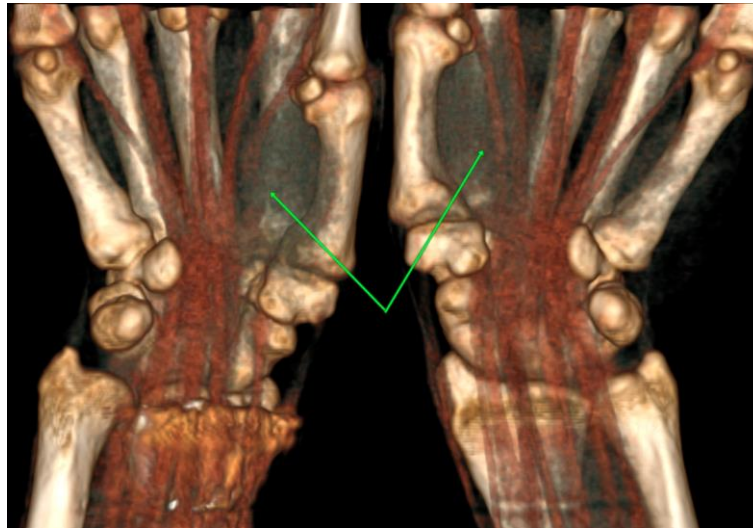
Upon examination, the right wrist showed no swelling, and the surgical scar had healed well. The patient had lost the ability to flex the distal phalanx of the thumb, but movements of other fingers were normal. A computed tomography scan, analyzed using RadiAnt DICOM Viewer software (Figure 1), showed a rupture of the FPL tendon, with the tendon on the unaffected side remaining

**Figure 1:** *The discontinuity of the FPL tendon at the distal site compared to the intact side (indicated by the green arrow) on the computed tomography scan*

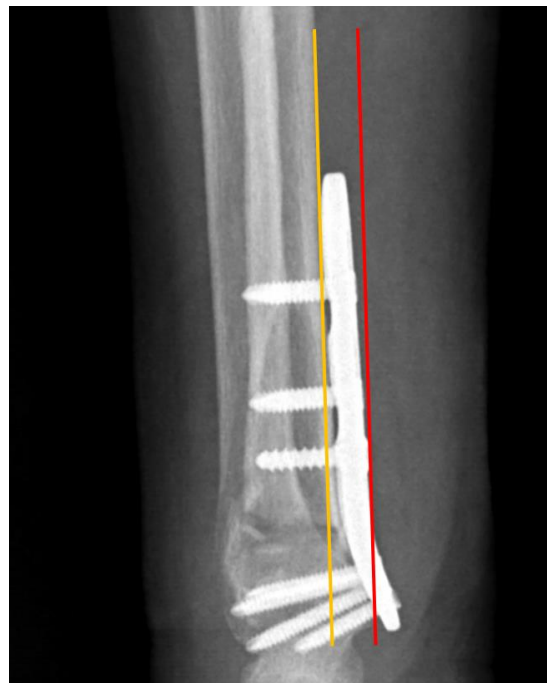
intact. X-rays of the wrist upon admission (Figure 2) showed that the plate was positioned low, classified as Soong grade 2 [1]. We explained to the patient that she would undergo surgery to remove the plate, explore and locate the ends of the ruptured

**Figure 2:** *The lateral X-ray shows a low positioning of the plate, Soong grade 2*

result in the edges of the plate becoming prominent, leading to tendon irritation or abrasion. Similarly, excessively long screws may protrude and damage the tendon during movement. Soong et al. (2011) classified plate prominence using lateral X-rays taken after surgery, employing a "critical line" drawn parallel to the radial shaft cortex. Plates placed near the volar rim of the distal radius but not exceeding this critical line were labeled as grade 0, those extending beyond it were grade 1, and plates positioned past the volar rim were graded as grade 2. The authors concluded that plates with greater prominence near the joint surface heightened the risk of flexor pollicis longus (FPL) tendon rupture [1]. Selvan (2014) also found that a radial inclination of less than 25° increases the risk of tendon rupture, whereas maintaining a greater distance between the joint surface and the plate reduces this risk [2]. Wurtzel's study (2017) emphasized that both volar tilt and wrist extension positioning significantly impact tendon-plate contact risk. If the volar tilt is not properly restored, tendon-plate contact can occur during wrist extension, potentially leading to flexor tendon injury. When the plate is positioned near the watershed line and the volar tilt is restored anatomically, no contact between the tendon and plate occurs. However, if the volar tilt deviates by +5° to -20° from the anatomical angle, tendon-plate contact may occur at 20° of wrist extension. If the plate is placed below the watershed line, tendon-plate contact can happen as early as 58° of wrist extension, even if the volar tilt is anatomically restored [6].

In this patient's case, the FPL tendon rupture was discovered 2 weeks before admission, likely due to multiple factors, including tendon degeneration from steroid injections and low plate positioning. As the patient moved her thumb, the tendon likely rubbed against the plate, leading to gradual rupture.

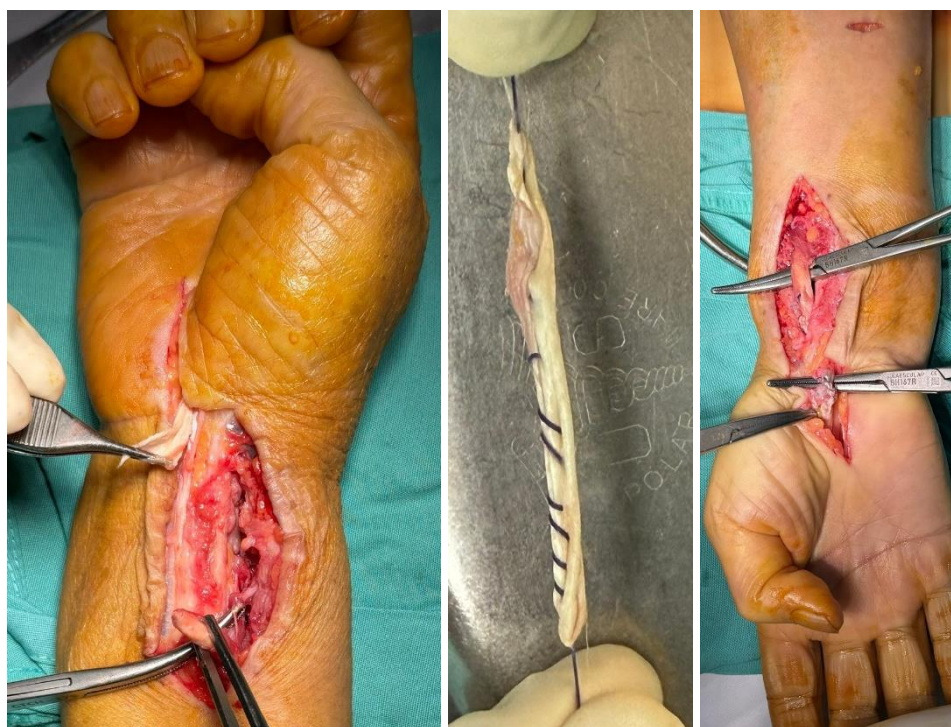
**Figure 3: Intraoperative illustration (from left to right: locating the two ends of the ruptured tendon, graft segment from the palmaris longus tendon, tendon after repair)**

In this specific case, we performed plate removal and tendon grafting using a segment from the palmaris longus tendon. At 6 months post-surgery, X-rays confirmed that the bone had healed, and the patient no longer experienced wrist pain, making plate removal a reasonable option to prevent the new grafted tendon from contacting the plate, which could compromise the surgical outcome. During surgery, we found that the tendon ends were far apart and degenerated, making direct repair impossible. Therefore, we opted for the palmaris longus tendon

graft, as it is a superficial tendon that is easy to locate and expose (Figure 3).

To minimize the risk of tendon adhesion to surrounding tissues, which could affect finger function, we used bio-adhesive glue to prevent adhesion by creating a lubricated surface between the tissues. Postoperative immobilization in the Edinburgh resting position was applied to prevent joint stiffness and contraction of the intrinsic muscles (lumbricals and interosseous muscles).

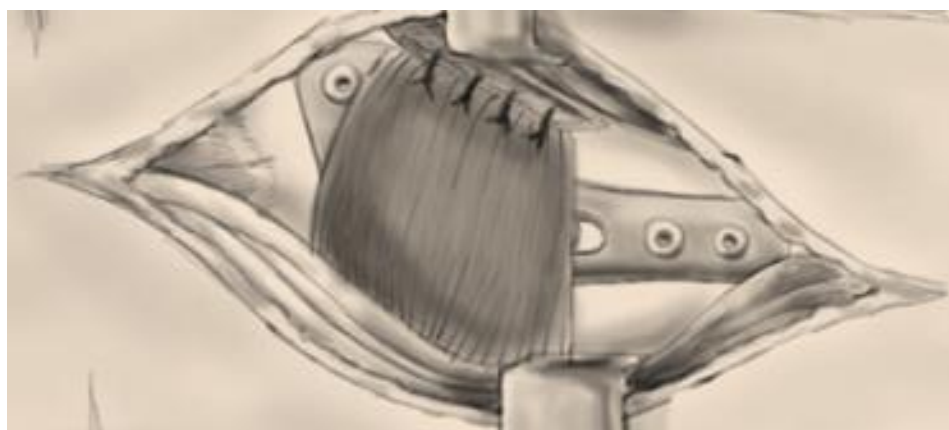
**Figure 4: Reattaching the pronator quadratus muscle following distal radius plate fixation**

Several solutions have been proposed to reduce the risk of tendon abrasion when placing the volar plate: Proper positioning of the plate in relation to the watershed line is essential from the outset. Ideally, the plate should align with or stay above the watershed line. However, this optimal placement can vary depending on the fracture type. For fractures extending below the watershed line, positioning the plate too far from the fracture site may fail to provide adequate stabilization for the fracture fragments [5]. Additionally, the pronator quadratus muscle is often re-sutured to cover the plate after its placement (Figure 4). During the procedure, the muscle must be incised to position the plate. Re-suturing aims to facilitate smoother flexor tendon gliding and minimize irritation caused by the plate. However, this step is not always effective, particularly in cases of complex fractures where the pronator quadratus muscle is extensively damaged, posing challenges for successful reconstruction [9].
